North Providence Schools Facility Study

Stage I

January 16, 2014

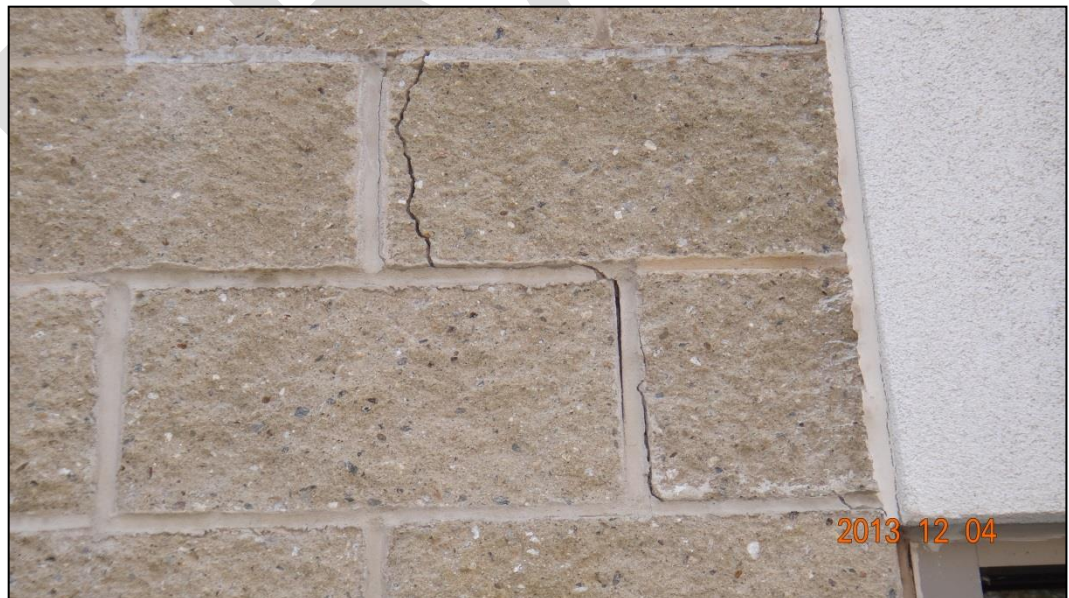
PHOTO #8 – *This photograph shows a closer view of the step-cracks in the split-face block veneer at the Birchwood Middle School building.*

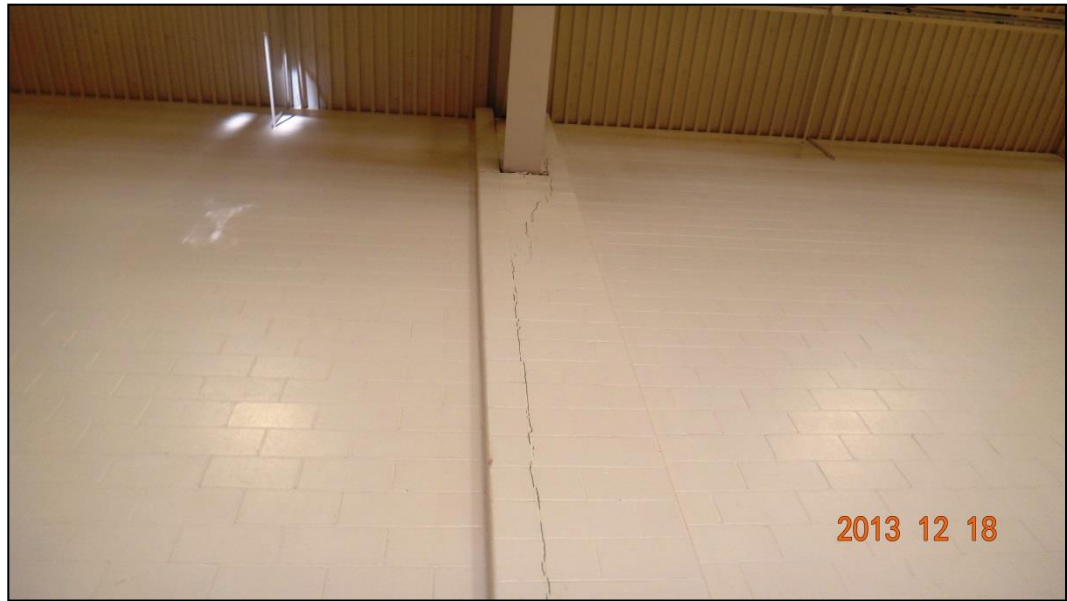
PHOTO #1 – *This photograph shows one of the locations where a vertical crack has developed in the concrete block piers surrounding the steel columns in the southeast gymnasium.*

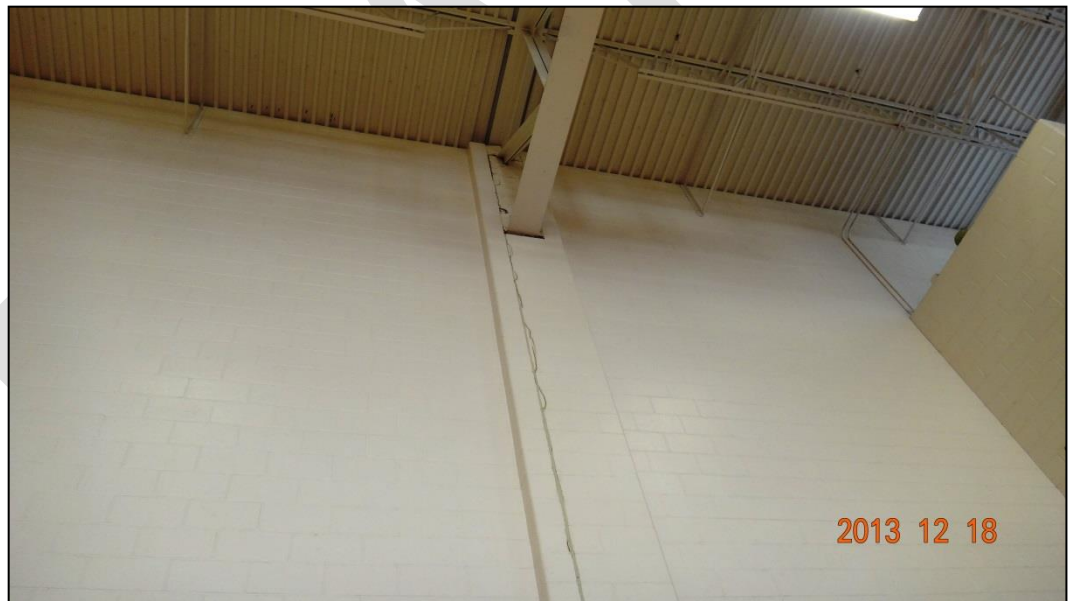
PHOTO #2 – *This photograph shows another location where cracks have developed in the concrete block piers surrounding the steel columns in the southeast gymnasium.*

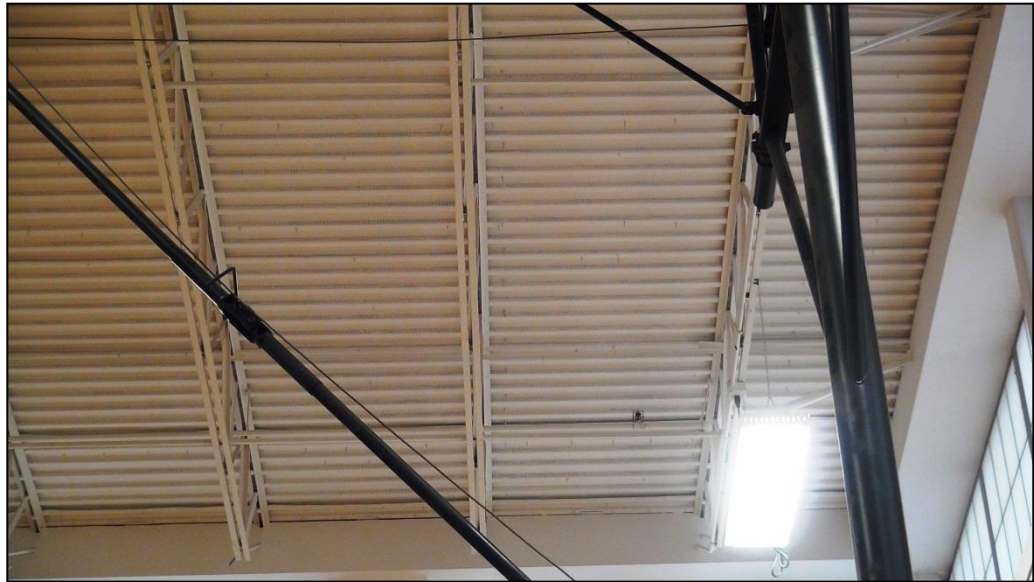
PHOTO #3 – *This photograph attempts to show the tilting of the bottom chord of one of the southeast gymnasium open-web steel roof joists.*

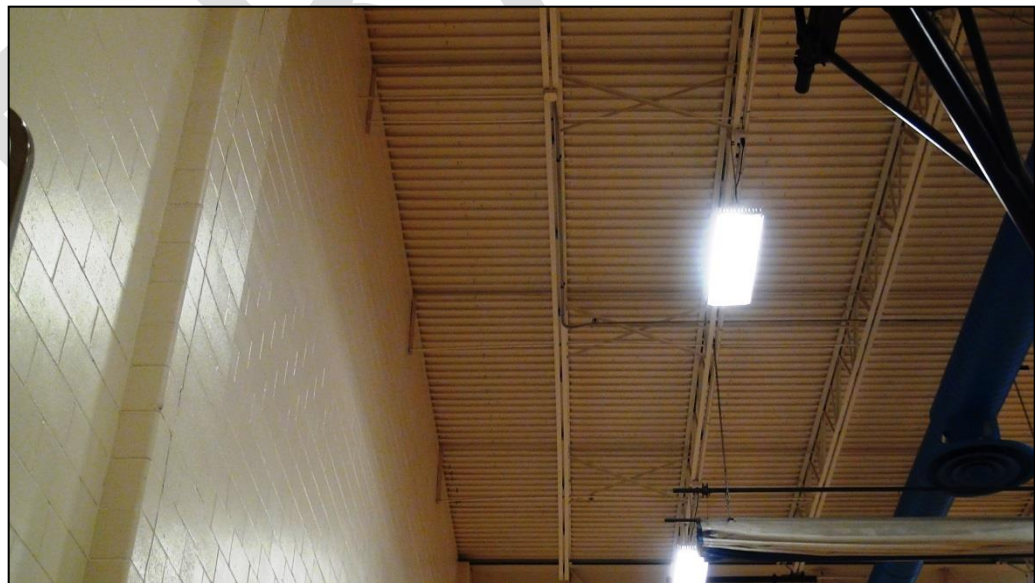
PHOTO #4 – *This photograph attempts to show the bowing of one of the southeast gymnasium open-web steel roof joists.*

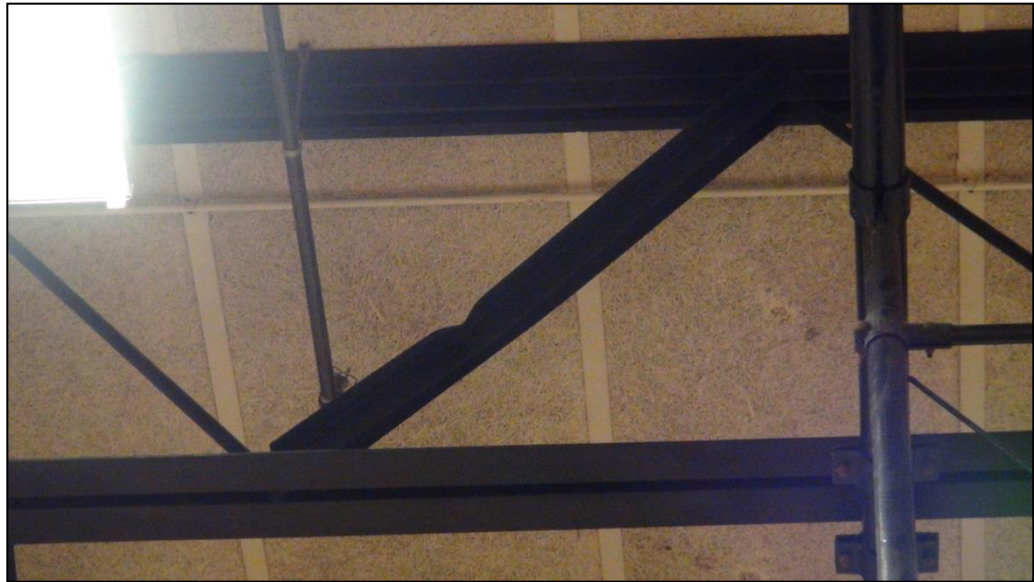
PHOTO #5 – *This photograph shows the damage to one of the southwest gymnasium roof truss web members.*

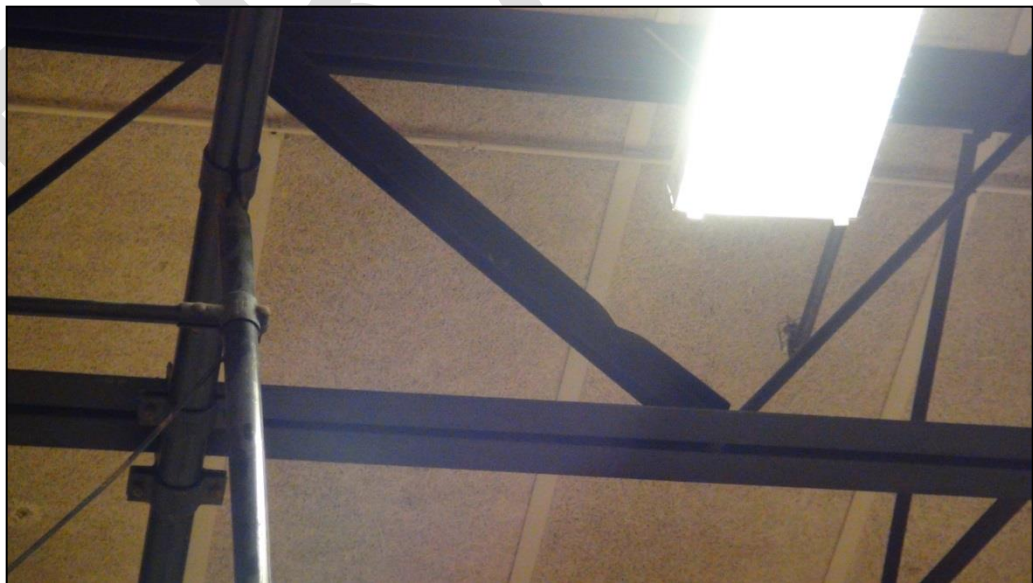
PHOTO #6 – *This photograph shows the damage to another of the roof truss web members in the southwest gymnasium of the North Providence High School.*

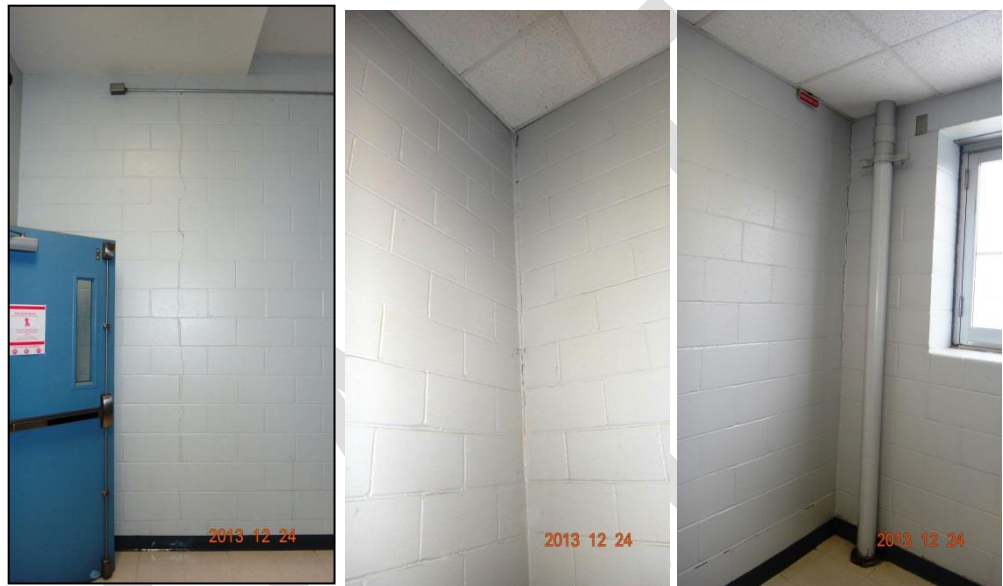
PHOTOS #7, #8 AND #9 – *These photographs attempt to show the cracking of the interior block walls at the connector stair tower near the southwest corner of the original High School building.*

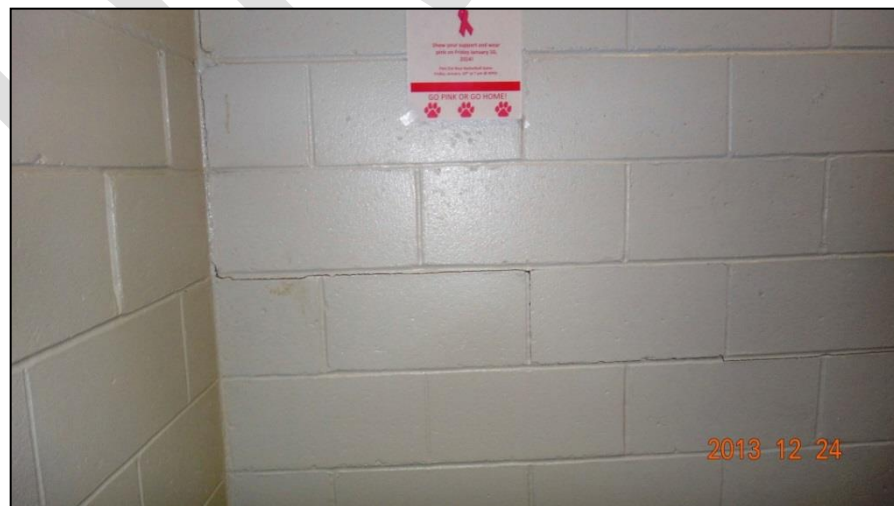
PHOTO #10 – *This photograph shows the horizontal and step-cracking of the interior block walls at the connector stair tower.*

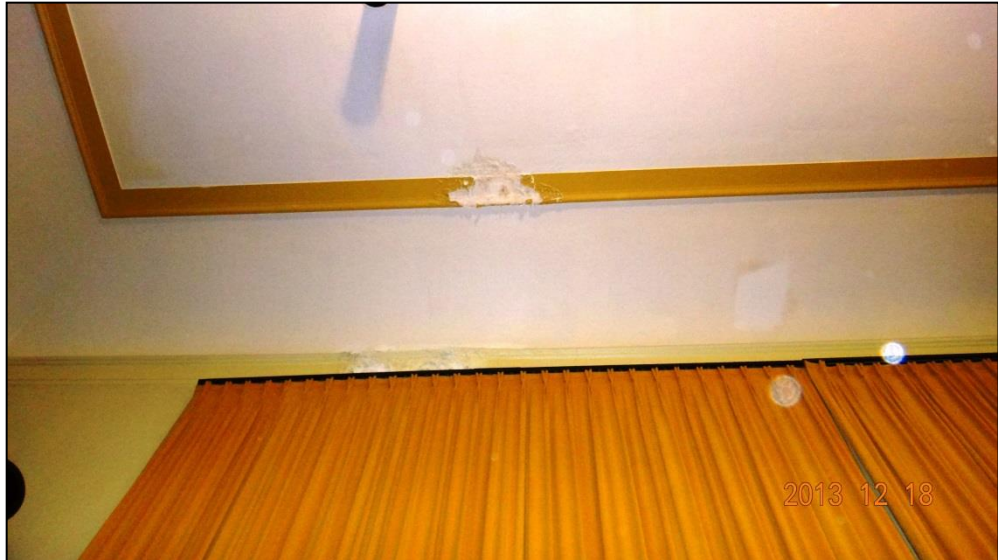
PHOTO #11 – *This photograph shows the damages to the Auditorium ceiling caused by roof leaks.*

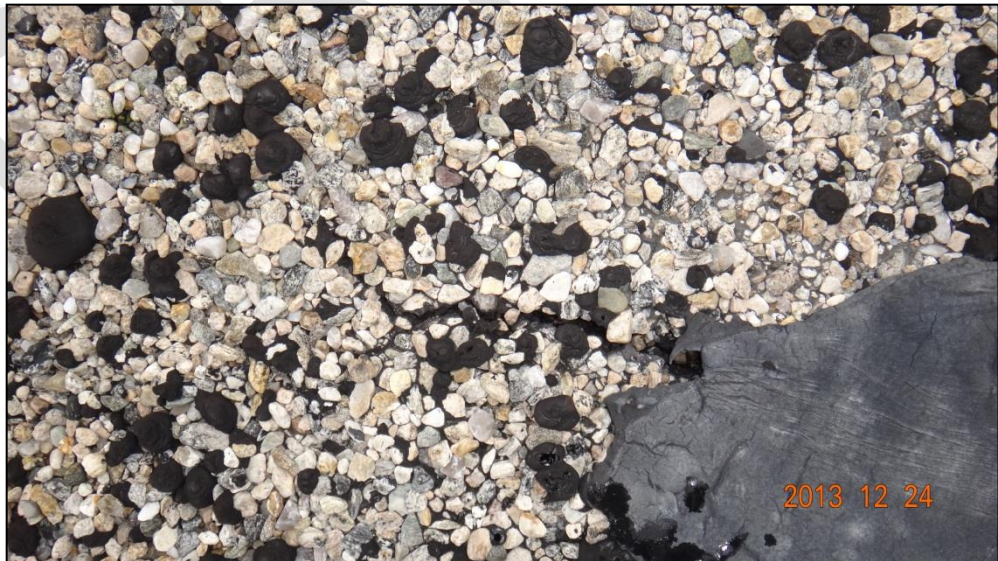
PHOTO #12 – *This photograph shows a crack in the roofing system on the original High School building roof located nearby and above the roof leak in the Auditorium shown in Photo #11.*

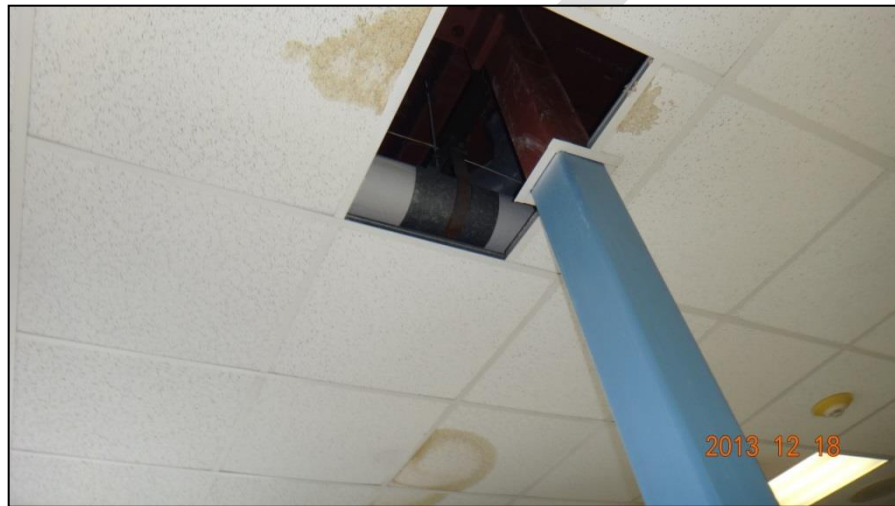
PHOTO #13 – *This photograph shows one of the locations where reported wind-driven rain is infiltrating into the building envelope and damaging the interior architectural finishes.*

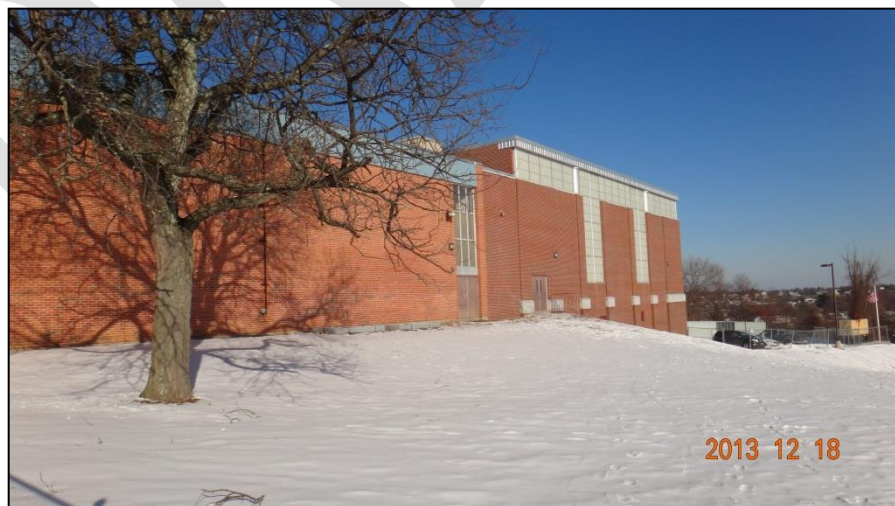
PHOTO #14 – *This photograph shows the south exterior wall of the southeast gymnasium where wind-driven rain has reportedly been infiltrating into the building envelope from the windows.*

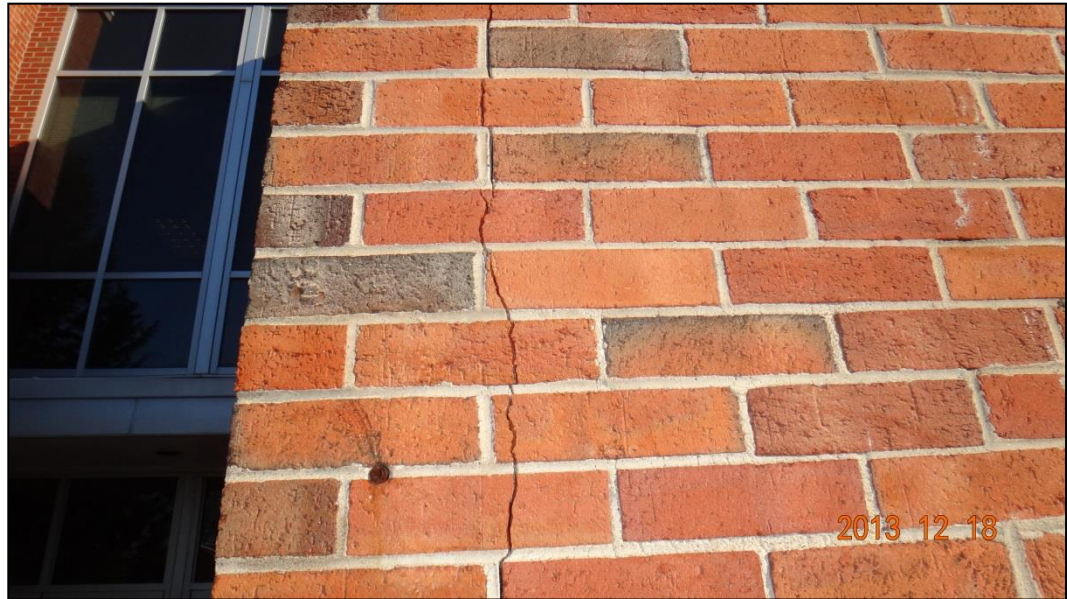
PHOTO #15 – *This photograph shows one of the locations where the exterior split-face masonry block joint sealant has cracked and failed.*

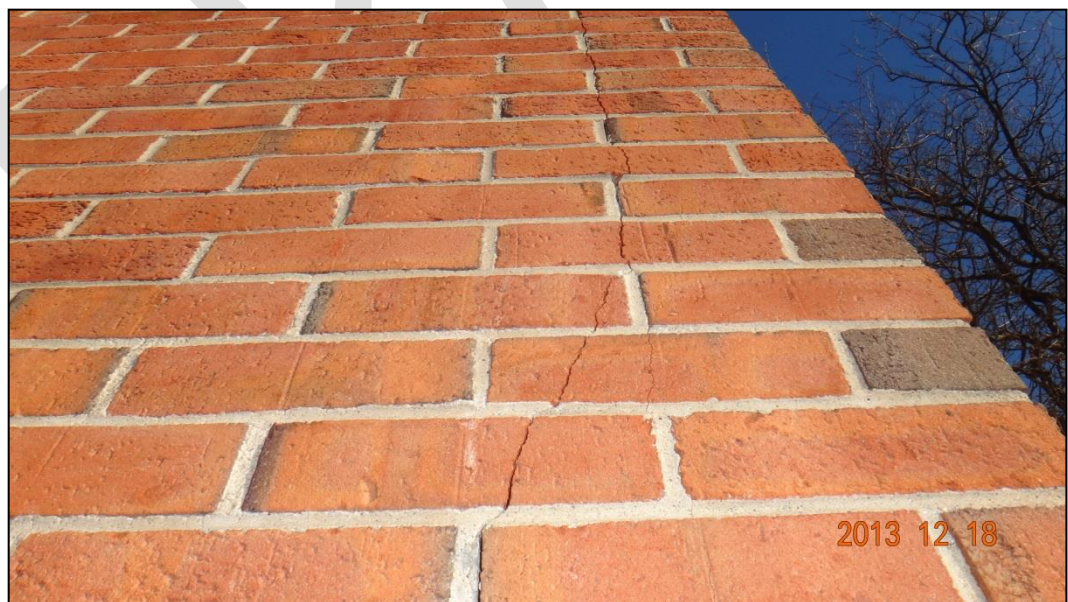
PHOTO #16 – *This photograph shows one of the locations where the joint sealant for the exterior wall split-face block joint sealant has lost the bond to the masonry block.*
